# Interior Report

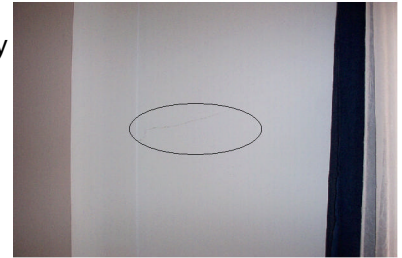
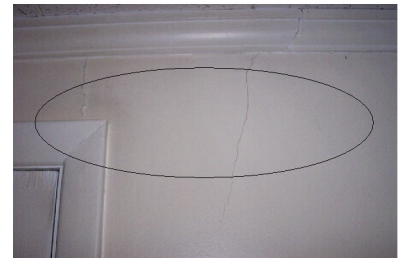
### WALLS:

Horizontal cracks noted on sides of Living Room bay window. Small vertical cracks noted in utility room around one window. We recommend the following- That you periodically monitor the condition of these components for signs of change that would signal the need for further evaluation. A licensed contractor or trades person should be consulted at that time for repair or replacement.

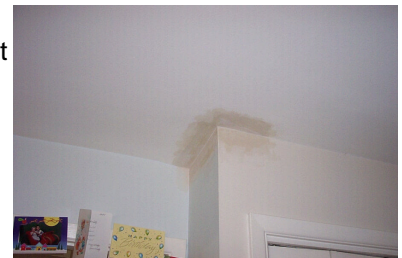
### CEILINGS:

Some waviness in living room ceiling is normal; no indication of structural problems. Truss uplift is noted in master bedroom and over kitchen door - a simple solution to this cosmetic problem is to add coves at these points.

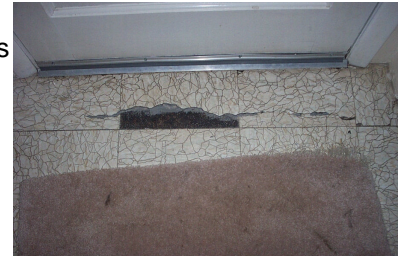
### FLOORS:

Inspection Limitations- Components were not inspected, No access is available- Components could not be viewed. OBSERVATIONS-Floor creaking upstairs can be repaired when carpeting is replaced. Downstairs floor has a noticeable unevenness. We recommend the following- That you periodically monitor the condition of these components for signs of change that would signal the need for further evaluation. A licensed contractor or trades person should be consulted at that time for repair or replacement. Picture of floor in front of rear door. Unable to

determine if movement of slab is ongoing at the time of inspection.

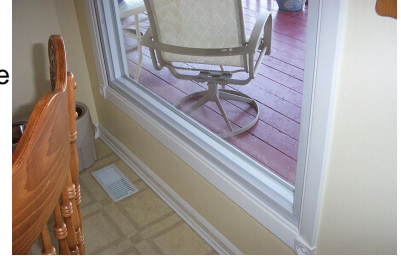
**WINDOWS:**

OBSERVATIONS- Components appear serviceable. It should be noted that thermal seal windows often lose their seal and evidence is not always available. Large kitchen window shows condensation marks between panes indicating a lose of seal.
